Target Status

29th October 2015 CM43

R78 Test Program

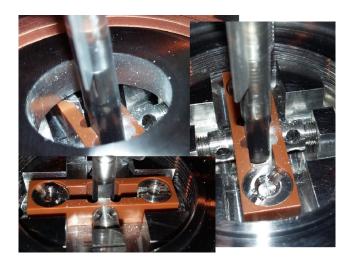
- Significantly less particulate matter! Acceptable levels.
- No evidence of migration of matter down the target into the vacuum chamber.
- Plan is to run S31c further with more inspections. (The bearing was NOT cleaned before it was closed back up).
- However, the control computer crashed and is under repair and will be re-installed ASAP since it is also the hot swap for the control computer on ISIS.
