# Status of the MICE Target(s)

Paul Hodgson

The University of Sheffield

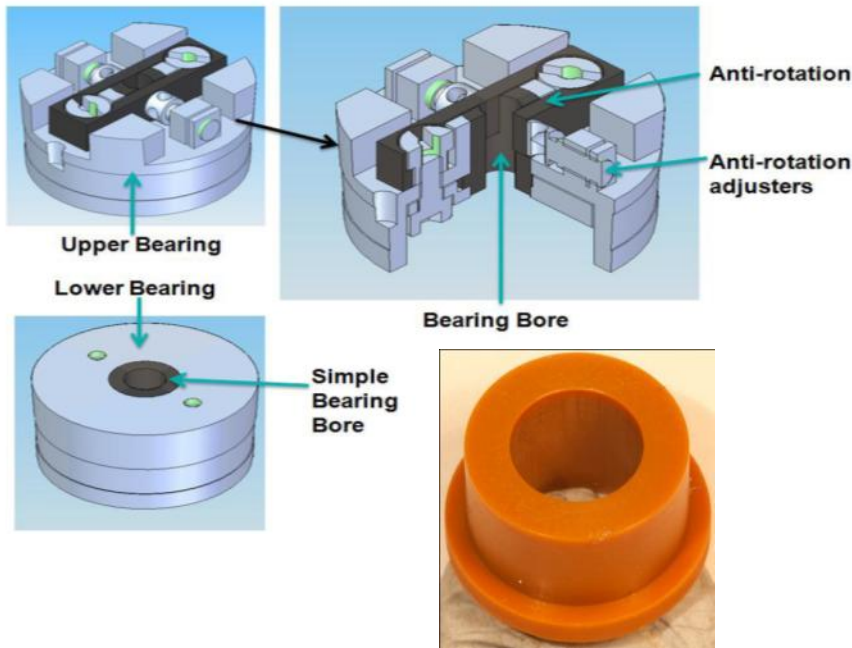
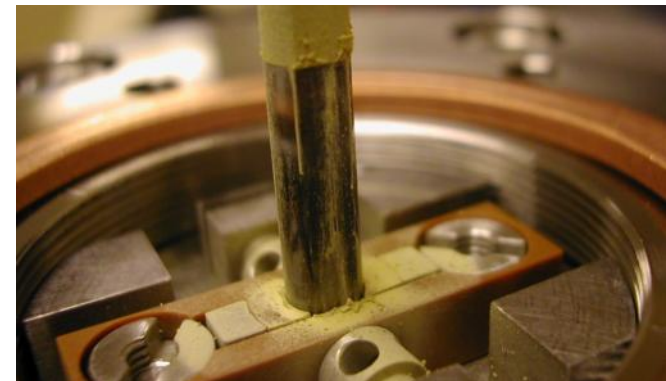
- 2.3 – DLC/Vespel tested early 2010
  - First try with the new Vespel (polyimide) bearings
  - Ran for 2.1 million pulses then stopped for inspection
  - Too much dust produced but otherwise encouraging
  - This was caused by poor finish on one side of DLC coated shaft
  - We had used a poorly finished shaft to allow rapid test while improved shafts were in production

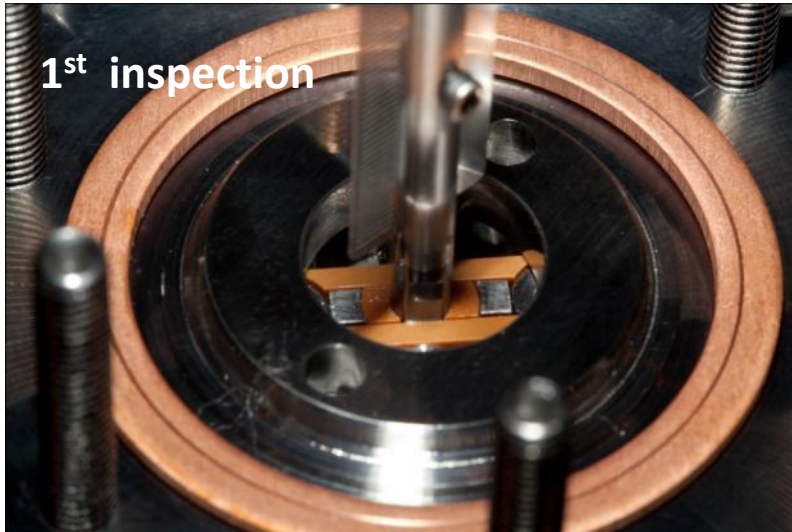
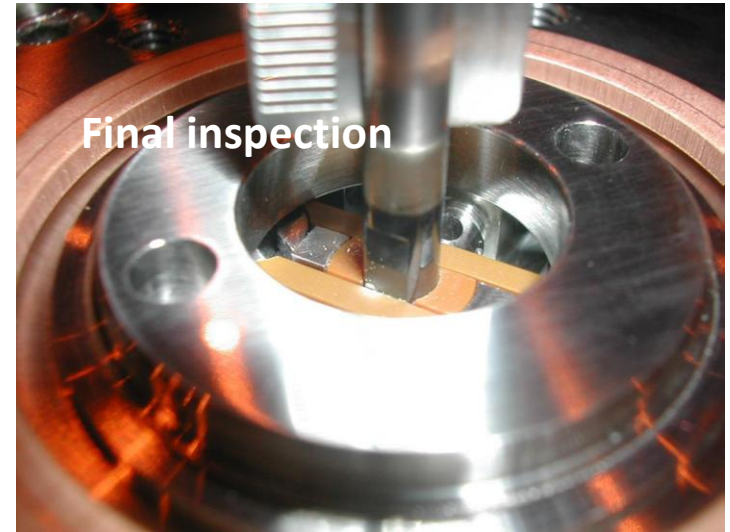
Wear on one corner

Shaft appears to be rotated in bearing

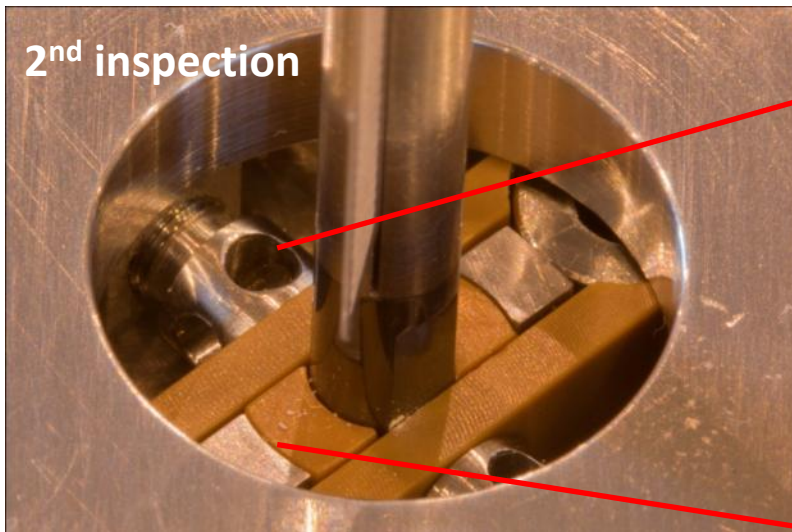
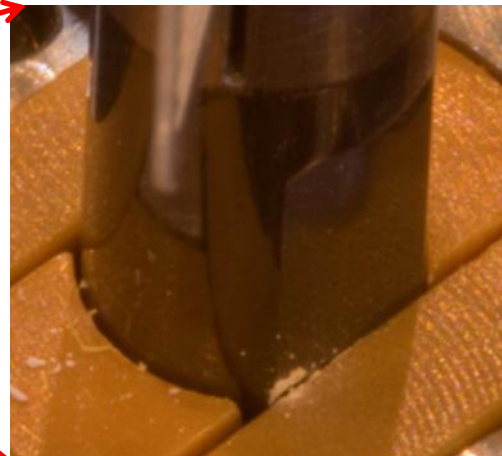
**Very little dust seen**

- The shaft was operated for approx. 1 million pulses.
- There was very little dust production.
- What material was produced was contained within the stator and the dust catcher.
- There was very little evidence of wear on the VESPEL bearings.
- The target became “stuck” in **capture position** several times.
- The sticking occurred at the top of the target trajectory.
- Bearings modified to mitigate against this.

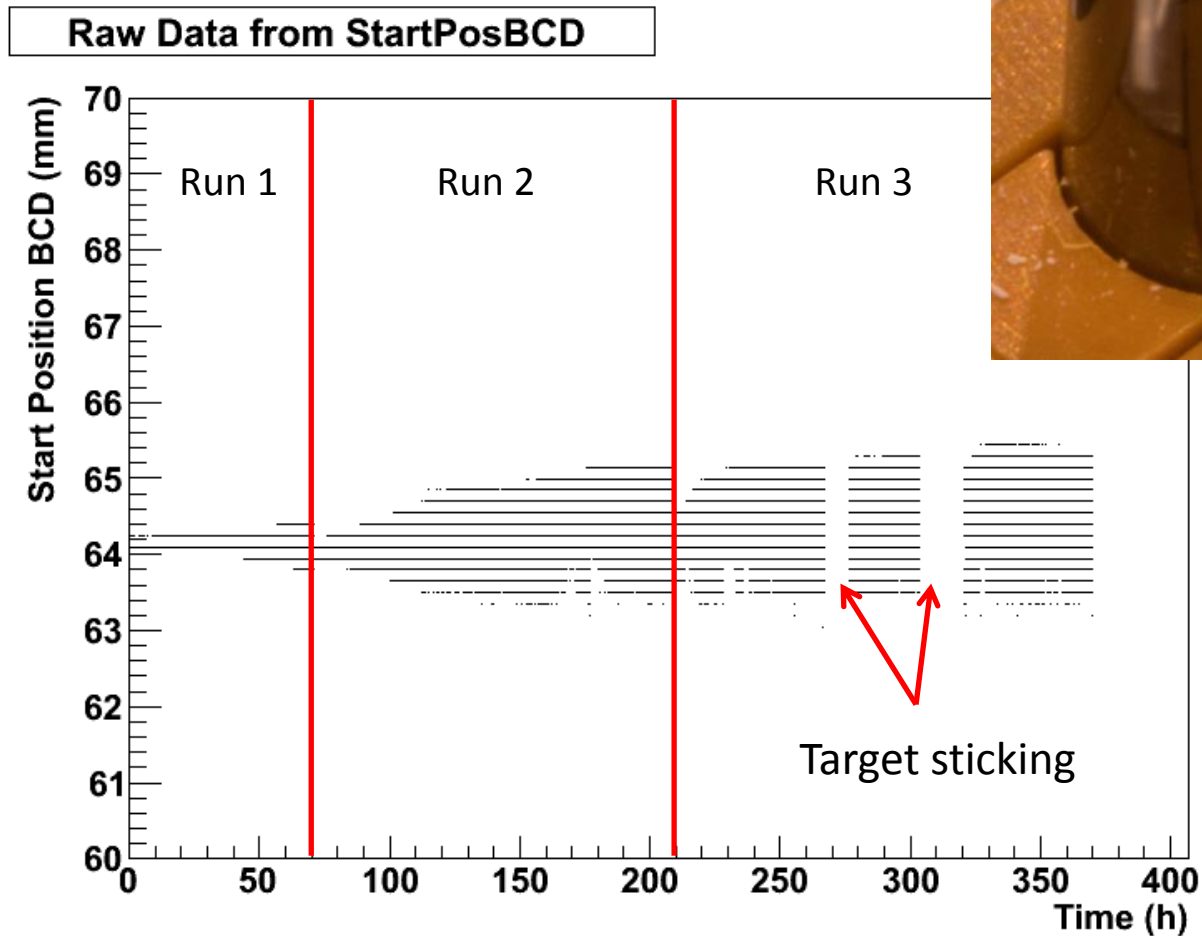
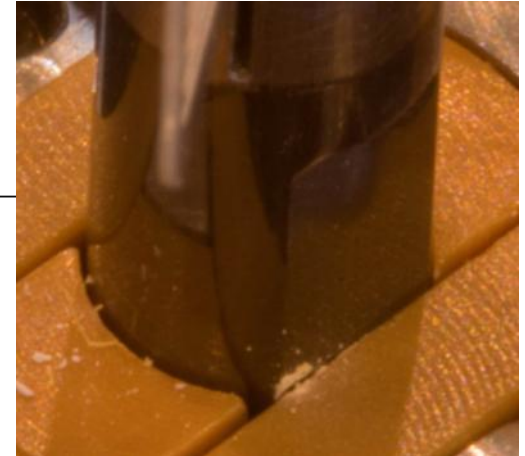
Target became “stuck” several times (8) during run

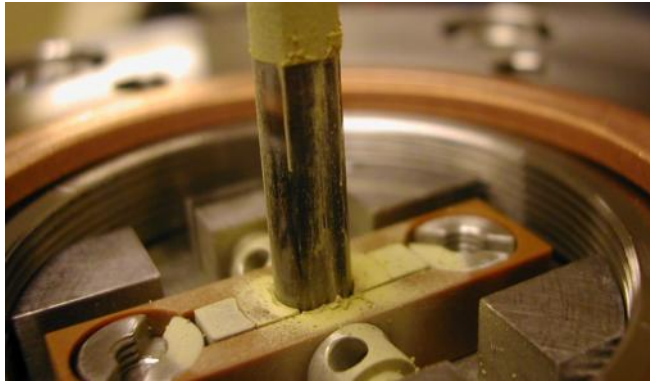
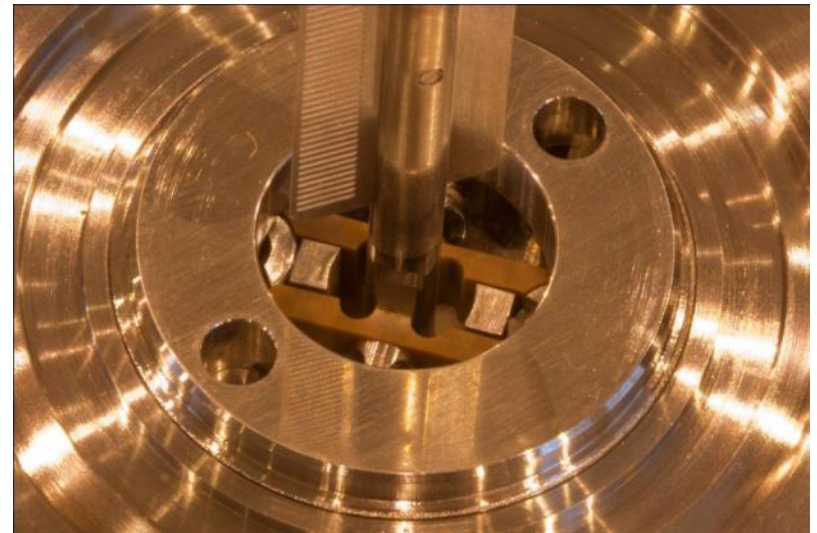
A major improvement

Remember that stator 2 would not pass new QA

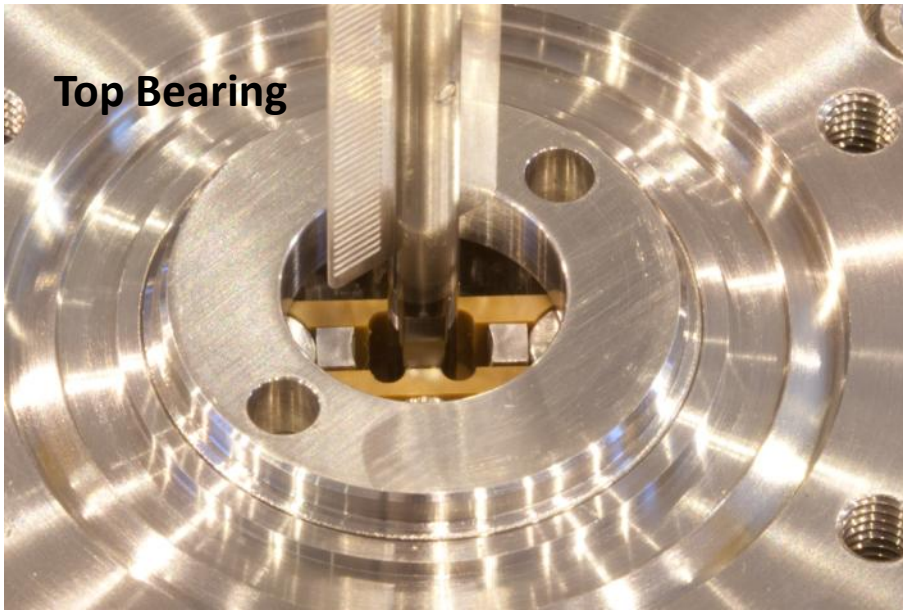
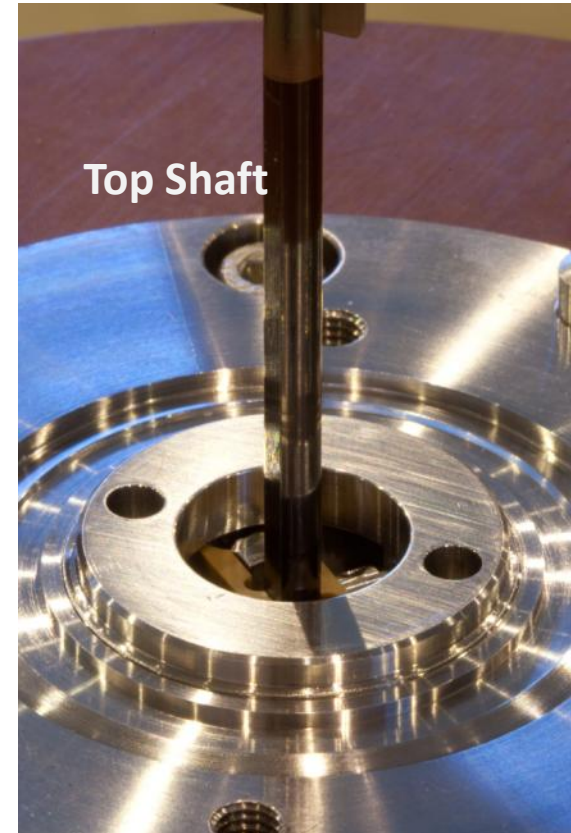
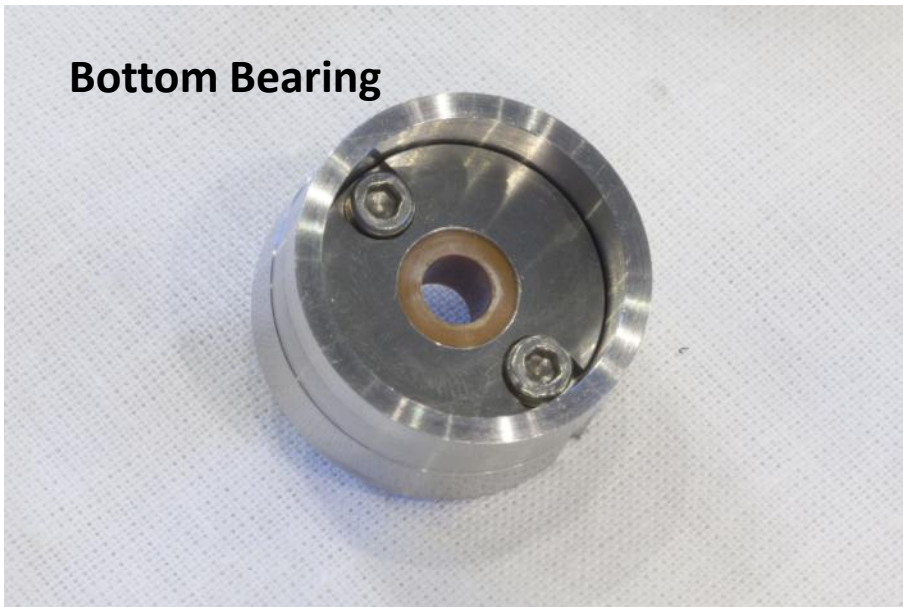
Very small amount of material visible
