# MICE Target Development

Chris Booth

8<sup>th</sup> June 2006

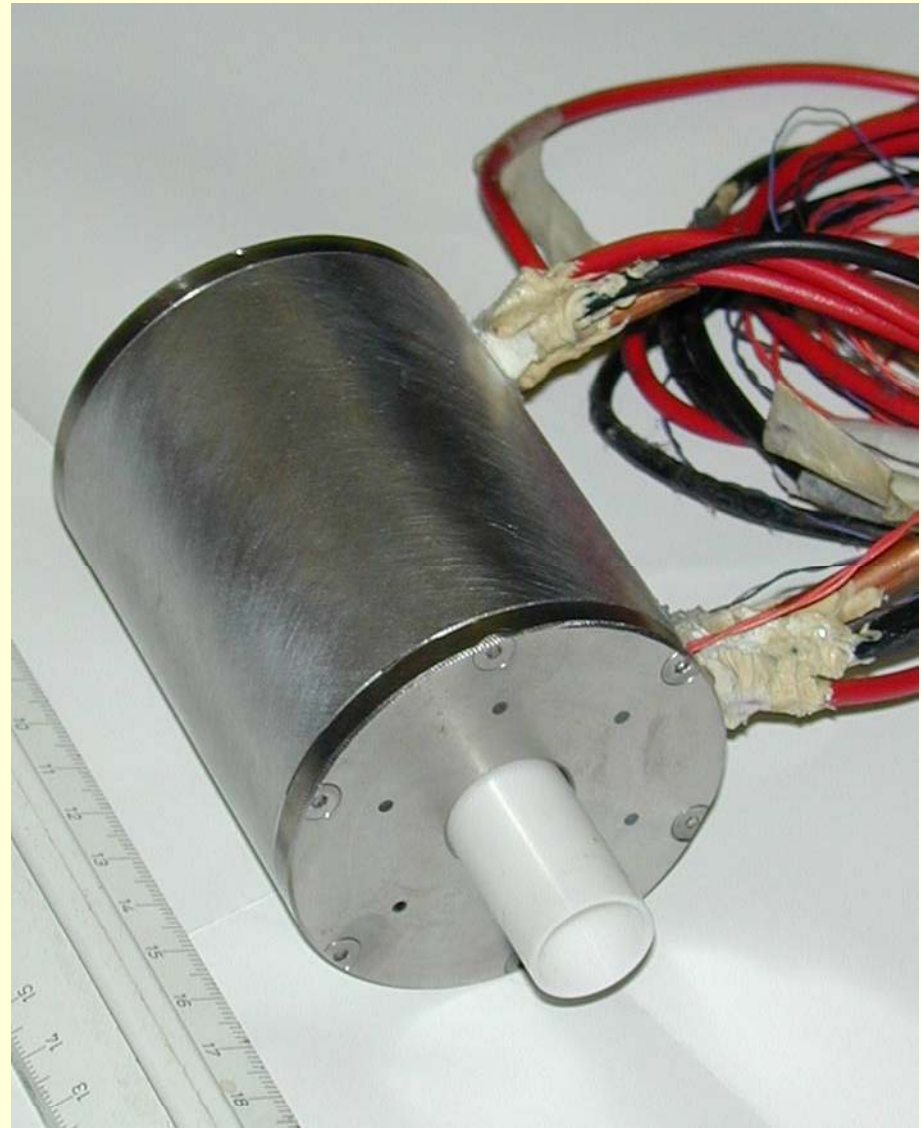
# Stator (1)

- Stator body from Manchester not built to specs.
- Micro-surgery allowed insertion of ceramic tube!
- We have learned how to make all components for future stators in house.

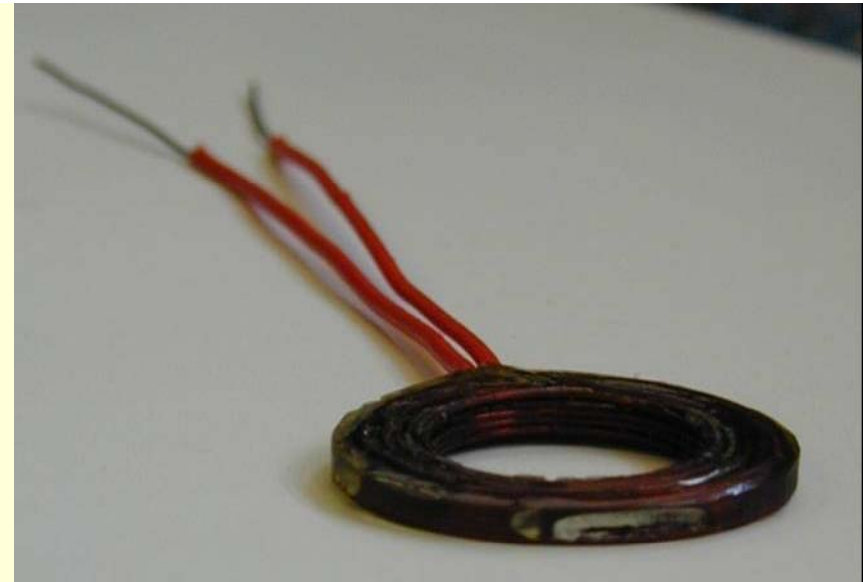
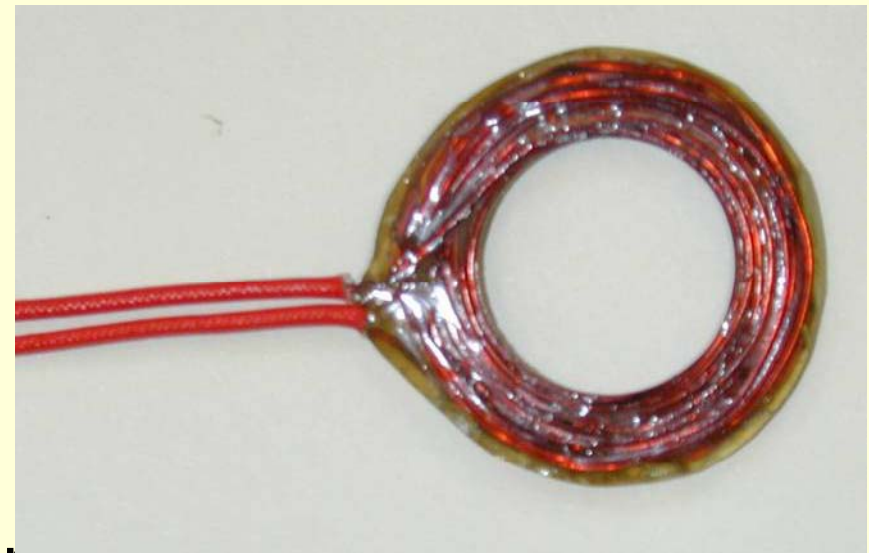
## Stator (2)

- Coil winding company provided satisfactory sample.
- 30 coils purchased, to construct new stator.
- Coils wound in-house also satisfactory.
- Will try new cooling and potting techniques in near future.

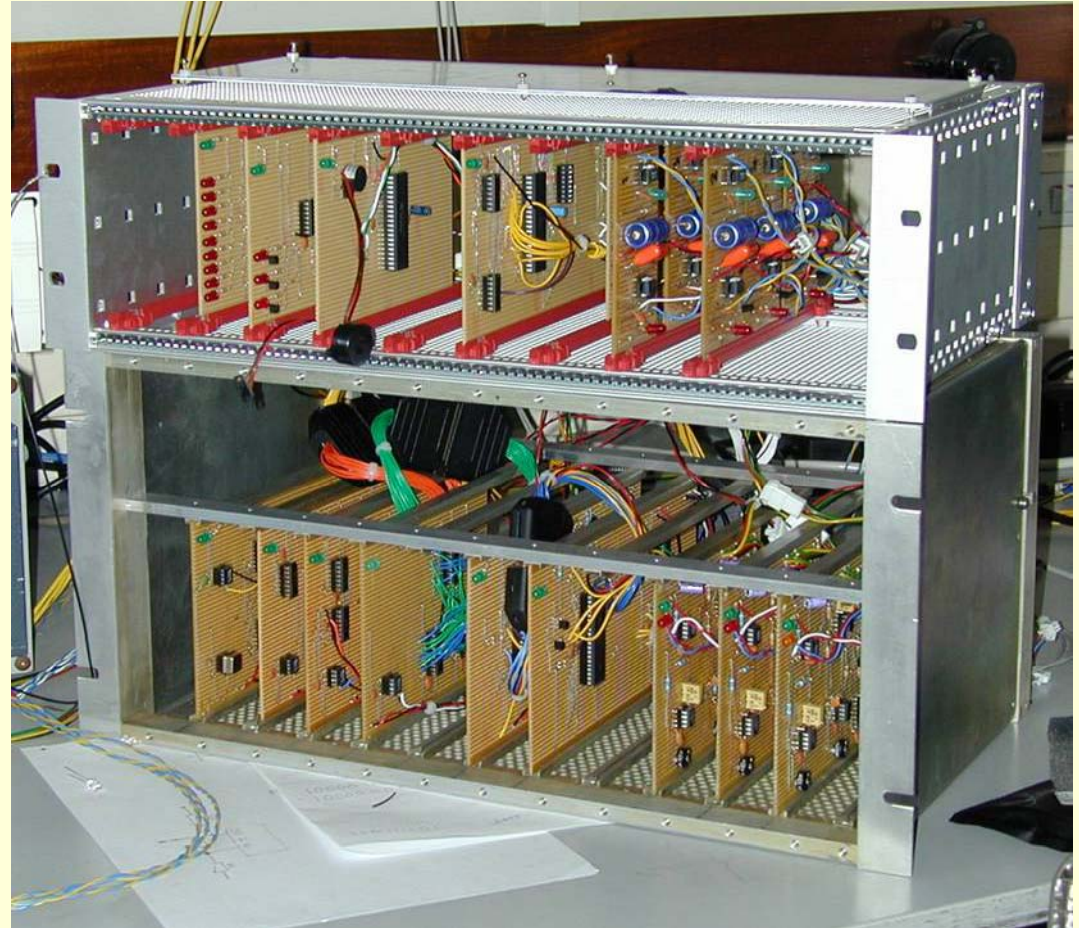
# Control electronics

- Cards now rack-mounted.
- Extensive tests with prototype drive. Several hours pulsing at 0.3 Hz (10 A).
- Some reliability & noise problems are being addressed.

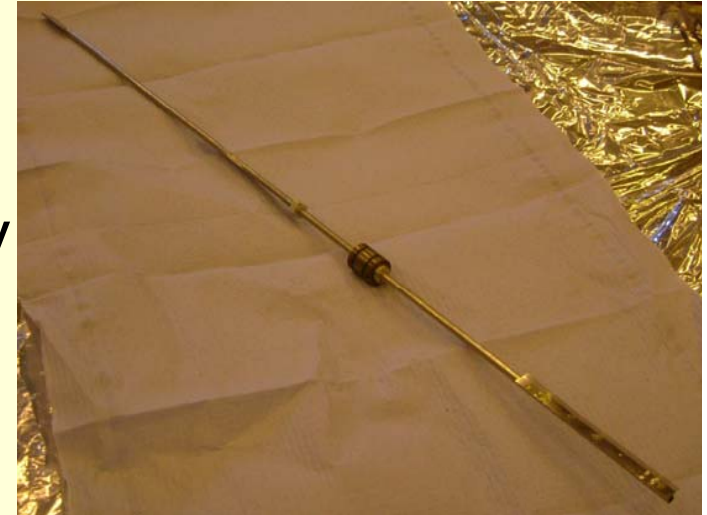
## 2. Target shuttle was distorted

- Slot cut along thin-walled tube to take alignment vane caused shaft to distort.
- Vane was twisted and slightly off-axis at one end.
- Would not pass through ceramic bearing.
- Slot & hole in bearing machined out to allow shaft and vane to pass.
- Some play and roughness, but movement satisfactory.

- Oxford redesigned target shuttle
  - Target, shaft, stop, alignment fin machined out of single piece of titanium.
  - Cross-shaped (or square?) cross-section.
  - Strong, no tendency to twist.
  - Only magnets and readout fin to be added.
  - New (or modified) ceramic bearings will be required – design to allow insertion of shaft through lower bearing for easier assembly.
  - Some questions have just arisen as to whether the shaft can be machined to this design! The design is under review.

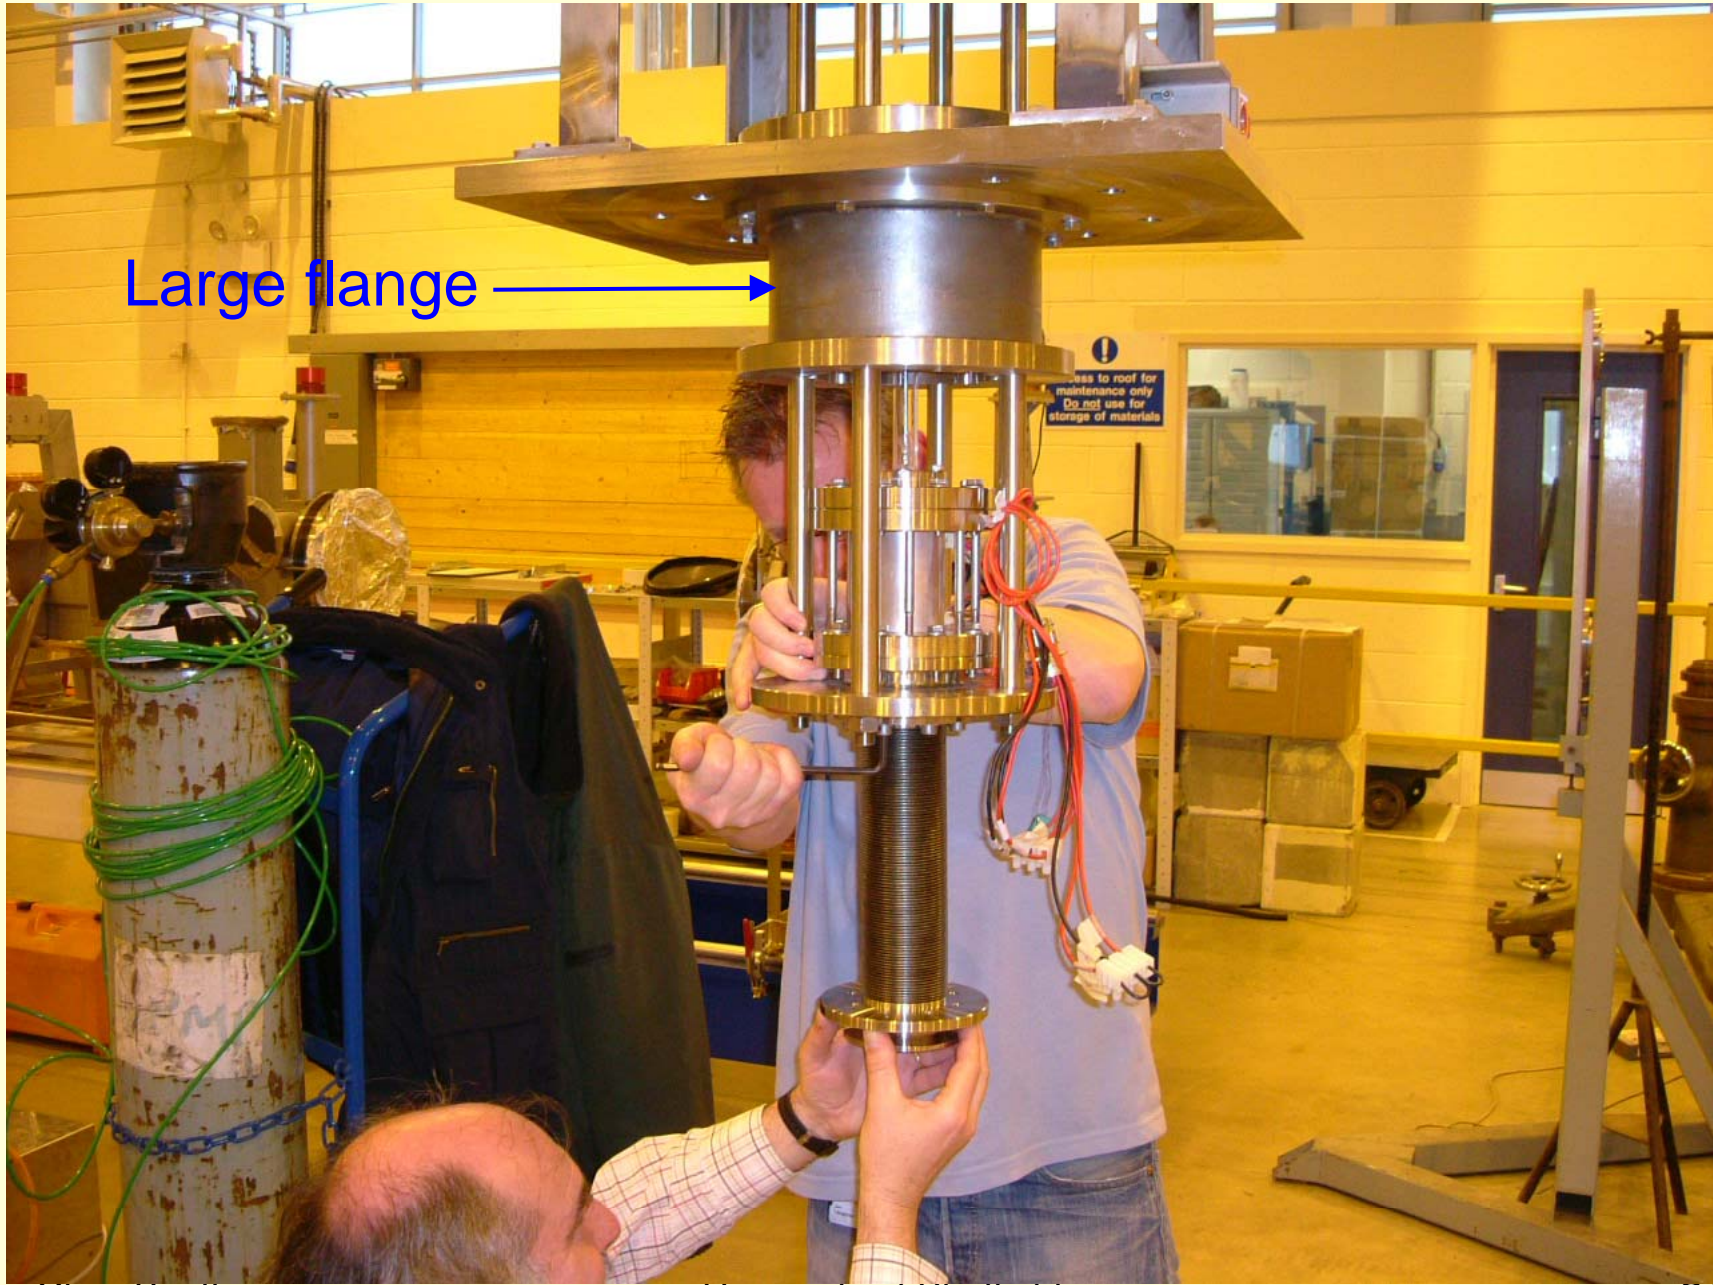
Large flange →

- Insufficient space for readout block around glass tube when drive in raised position.
- Large guide flange removed – appears not to be necessary.
- Flange could also be machined down to allow space.
