MICE Target

**MICE
CM 18
RAL June 2007**

**P J Smith
University of
Sheffield**

Target Progress Summary

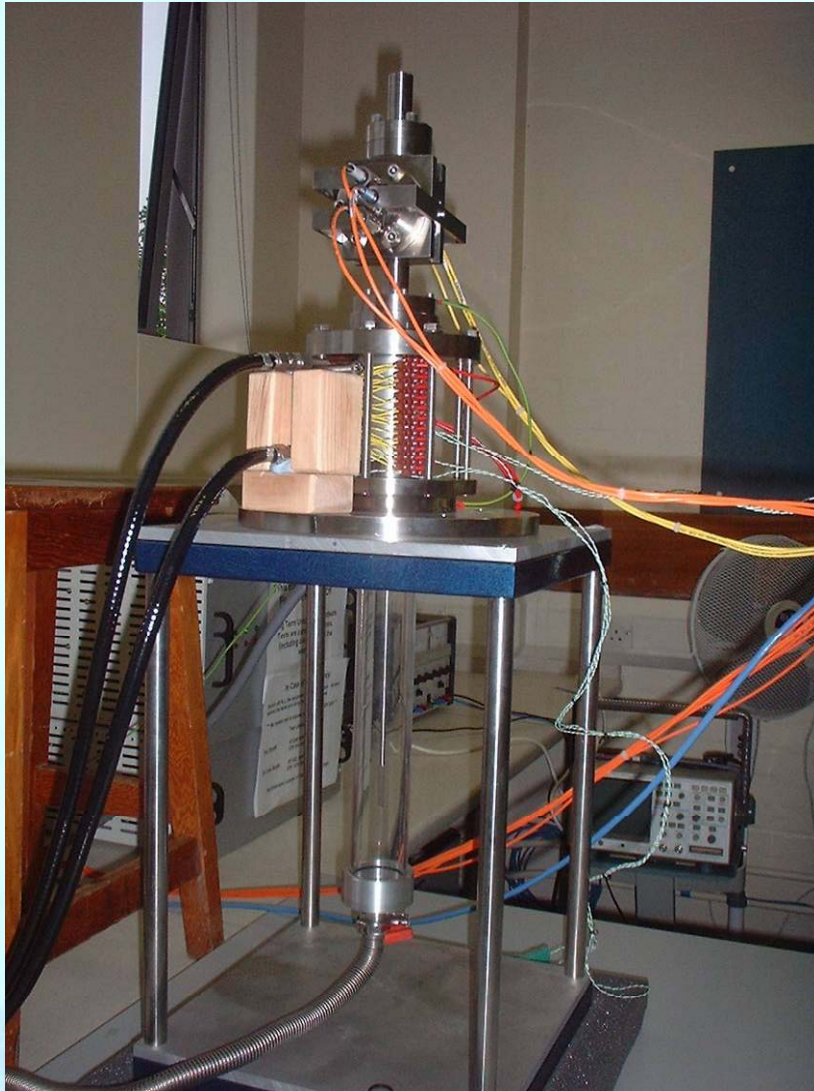
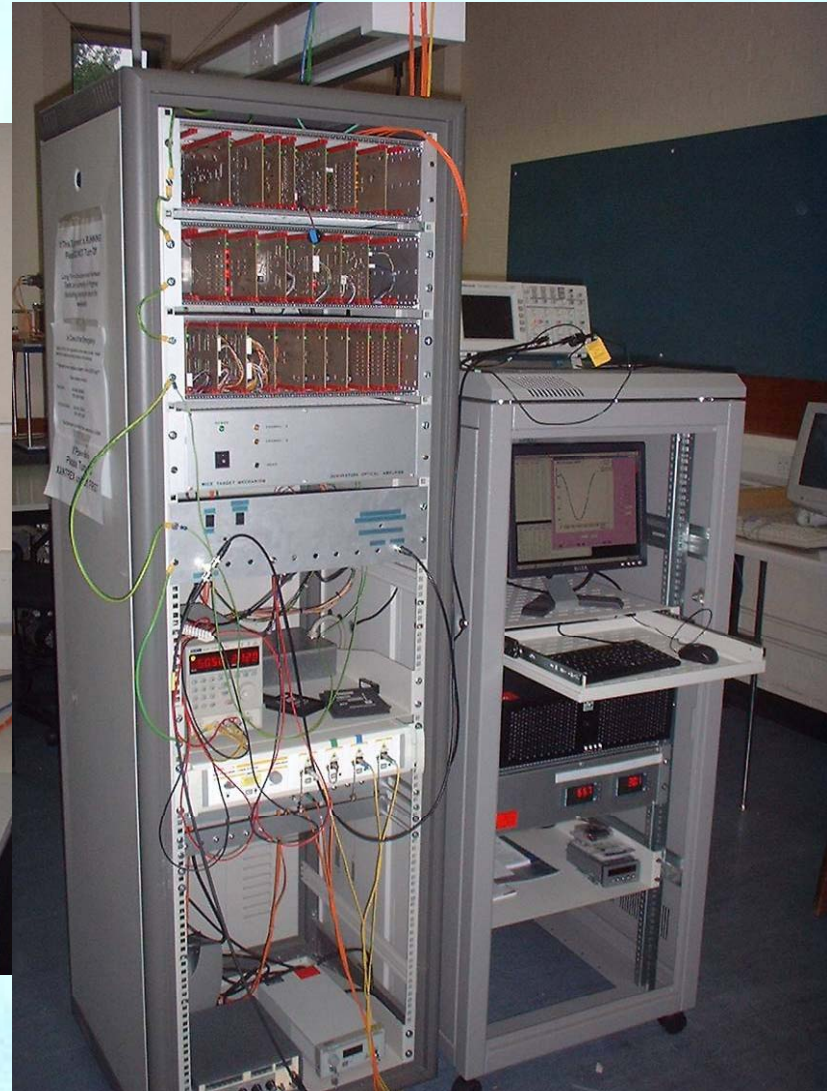
Photos of Setup

- Temperature Protection system put in place April 07 – This allows unsupervised 24/7 running
- Power supply received from Daresbury
 - Tested at Daresbury up to 70 Amps
 - Theoretically it could deliver up to 80 Amps

Note that we had previously only been able to deliver 10Amps to our actuator!
- Started running at low currents for several hours at a time
- Increased the coil currents as confidence with the system increased and problems were resolved. Running at 60 Amps coil current. (Will shortly show how that corresponds to acceleration and trajectory)

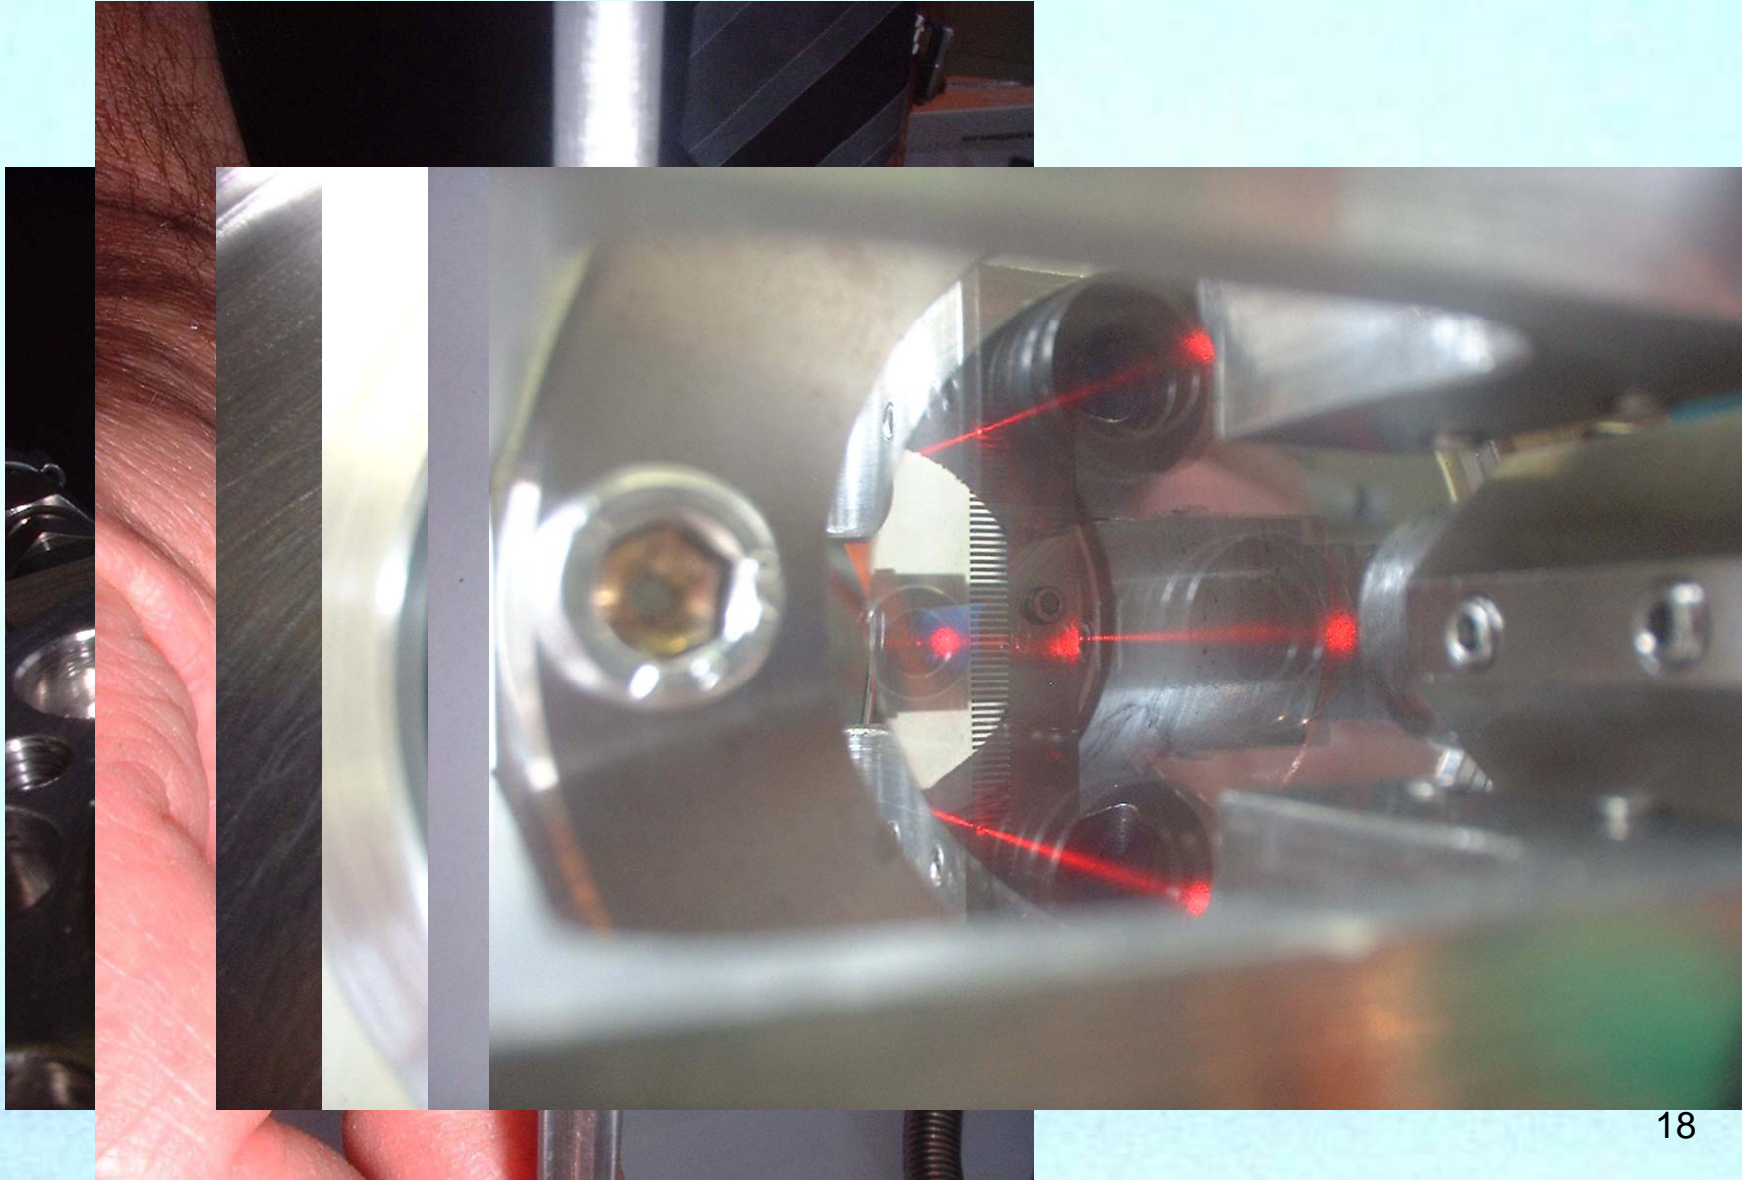
- Bearings – We were running on ceramic bearings
- Photos on next slide– Wearing out in typically around 100,000 actuations
- 3 possible elements to this problem
 - Is the Bearing material not suitable? – Ceramic material is relatively ‘soft’
 - Is the shaft not straight?
 - Is there a radial force on the target shaft?

Typically ~100,000 Actuations

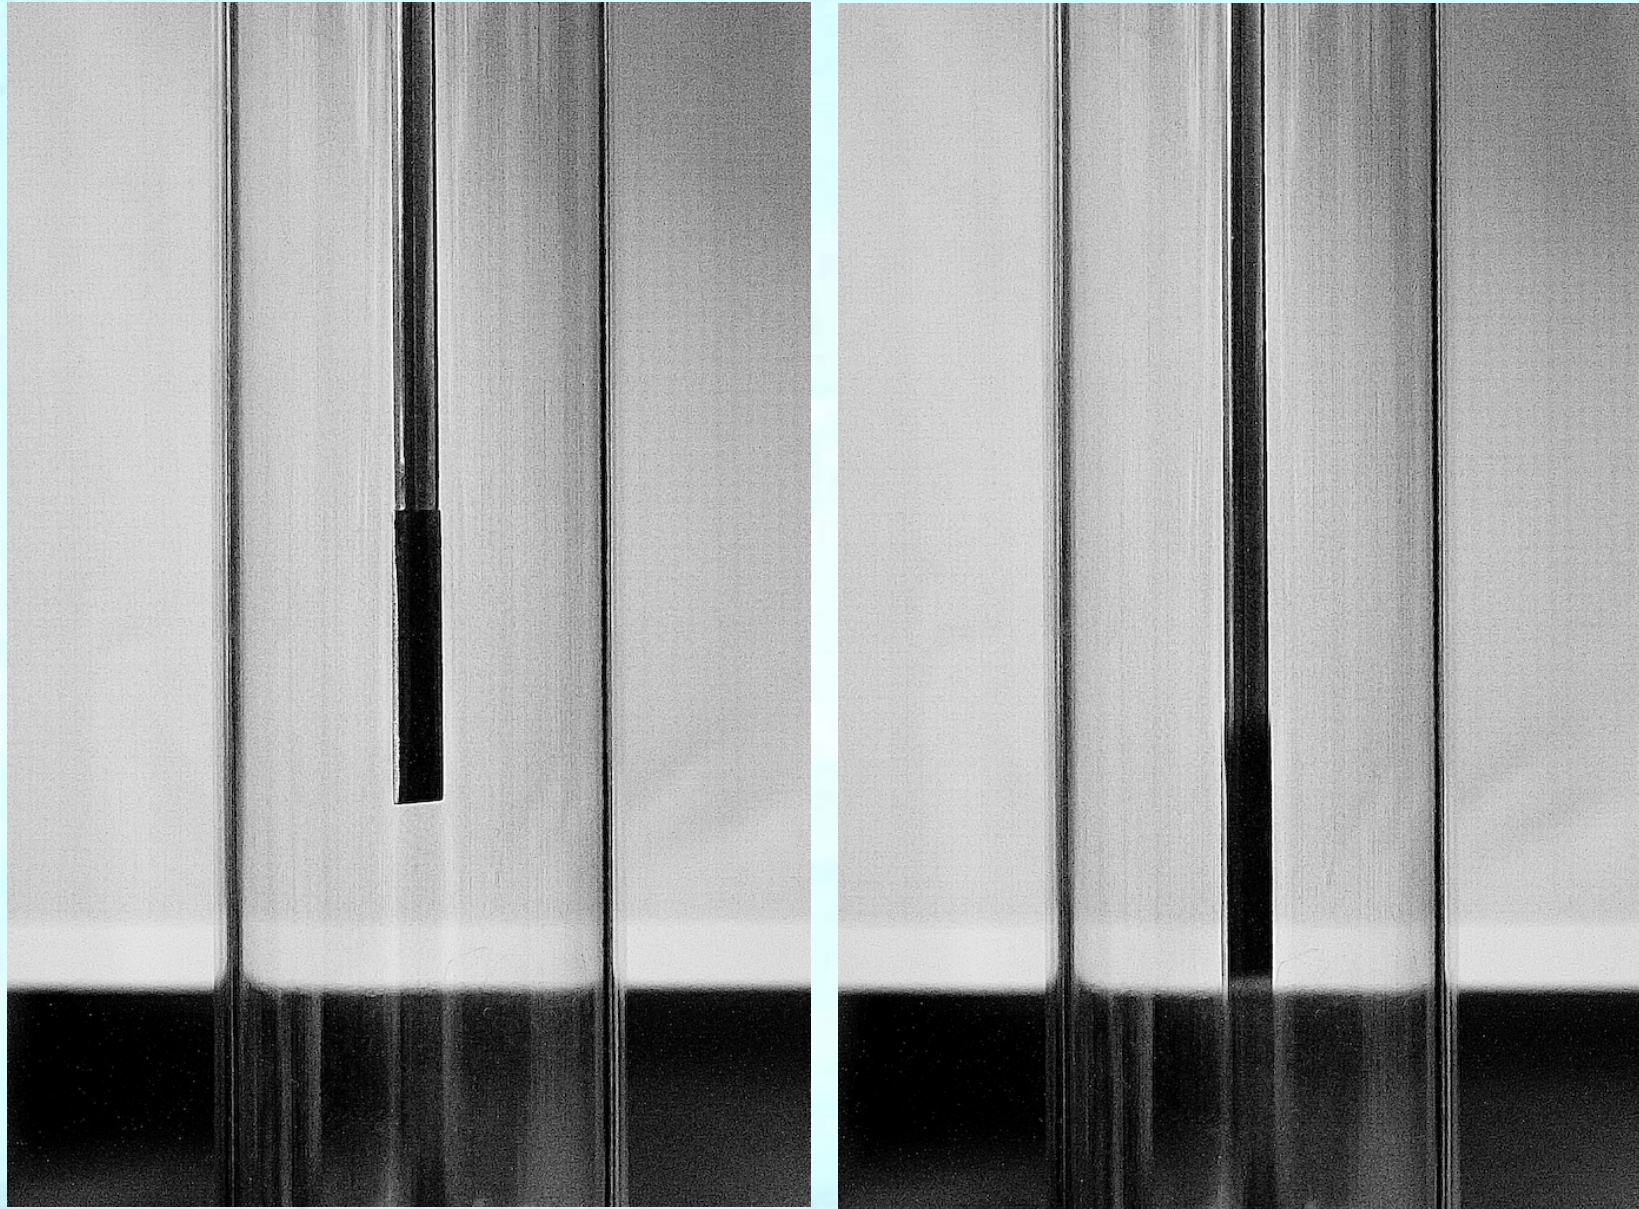
2 High Speed Photographs (10mS) taken of the target movement at 80g acceleration₂₅
