# Status of the MICE Target(s)

Paul Hodgson

The University of Sheffield

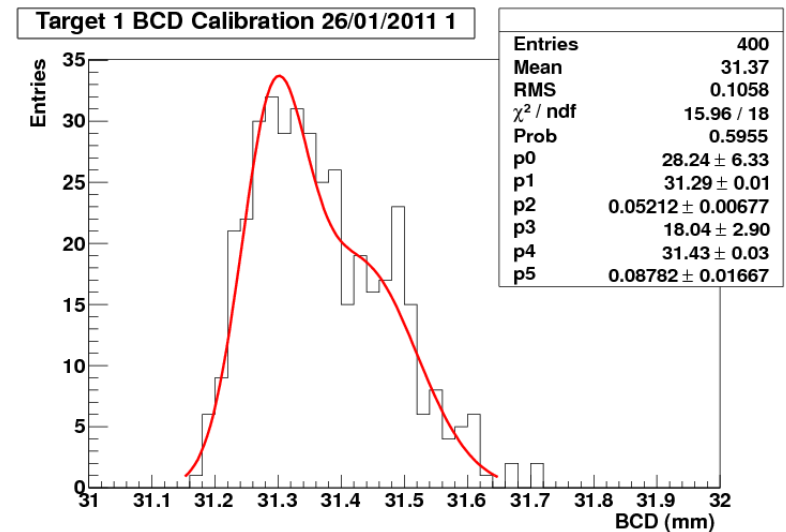
- 26-01-2011 - T1 was re-commissioned
- Visual inspection
- Chiller unit in catacombs had failed
- Replaced with one from R78
- Vacuum valve opened
- Controls/Electronics tested
- Frame raised/lowered – new PPS system in place
- Target operated at calibration BCD for 400 pulses
- Everything looks fine
- Ready for operation in 2011

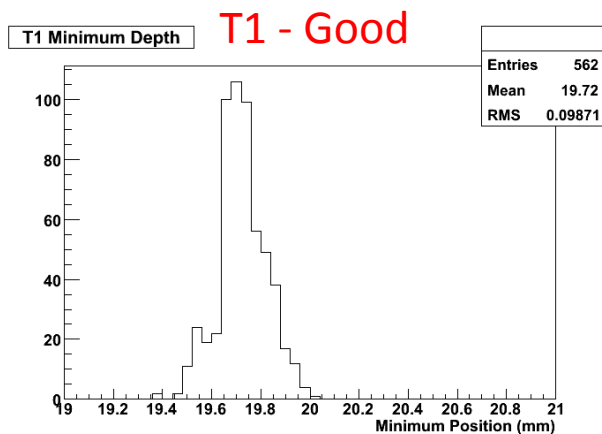
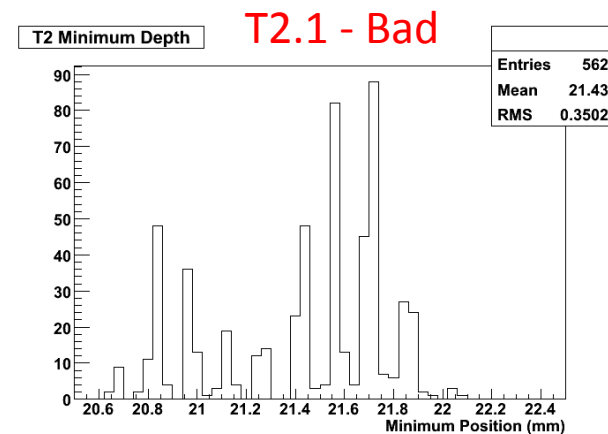
- 2.1 – DLC/DLC
  - After examining plots decided that the performance was unacceptable
  - Ended test after 1000 pulses

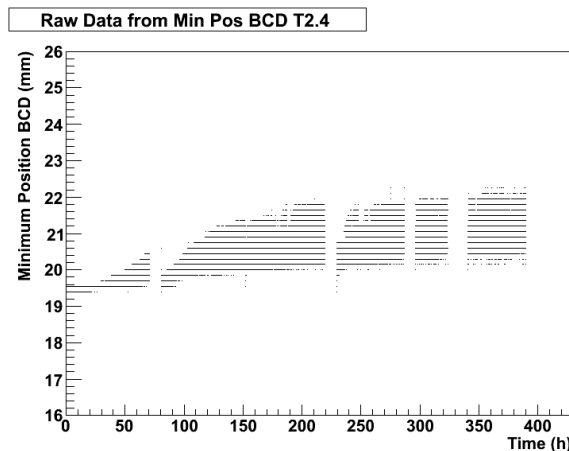
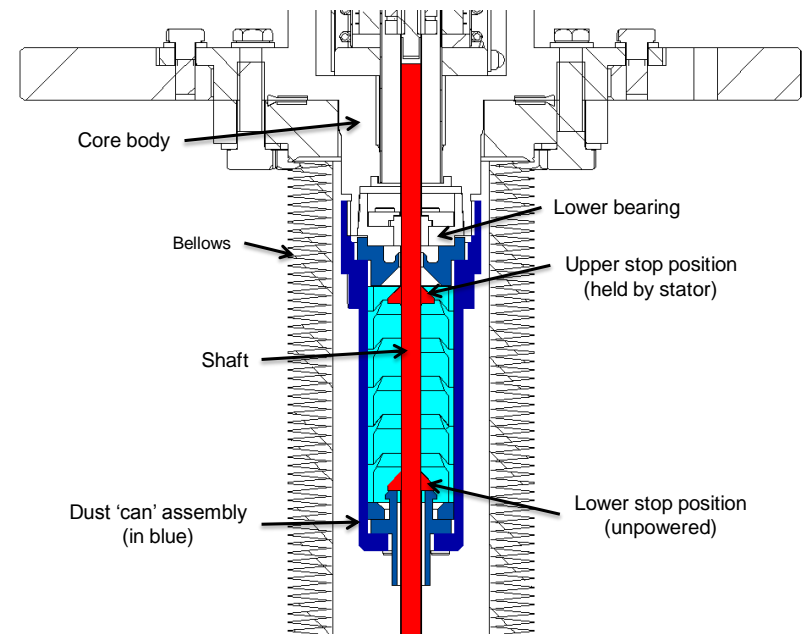
- T2.4 DLC/Vespel – Installed Nov 2010
- Improved surface finishes on shaft and bearings
- Dust Catcher added below bottom bearing
- Ran target for ~1 million pulses
- Inspect weekly (500k)
- Using the new FPGA controller
- Digital data

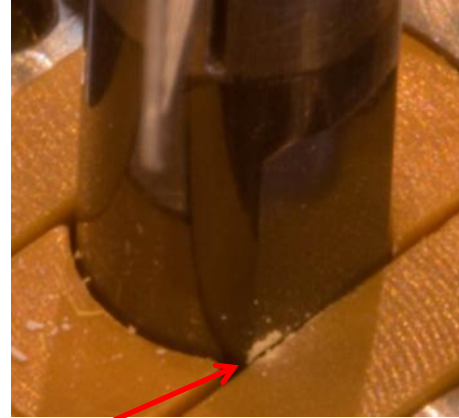
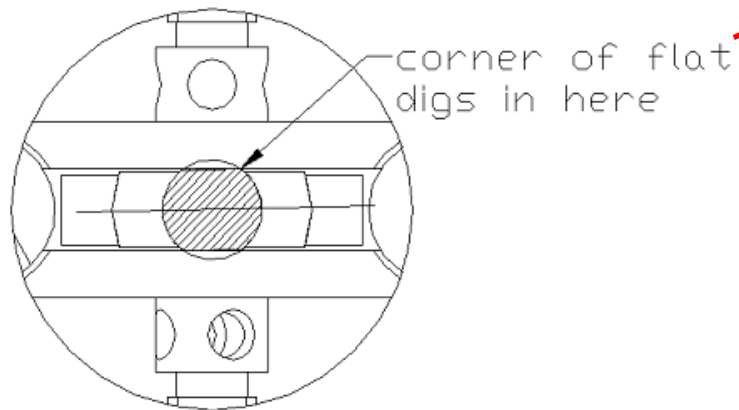
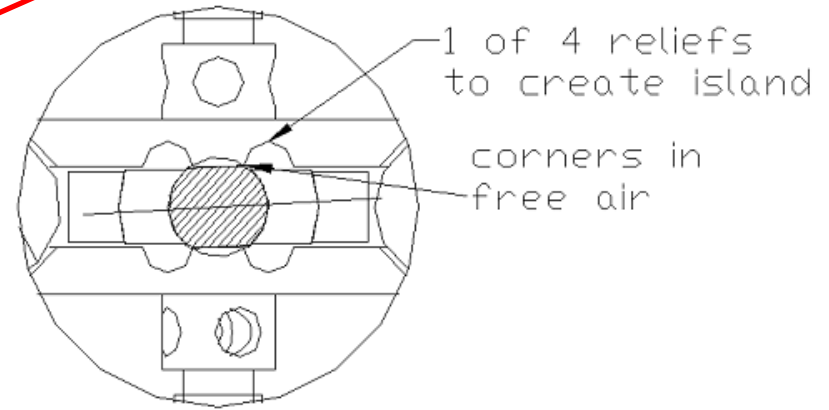
- 2.5 – DLC/Vespel
- Top Bearing Modified

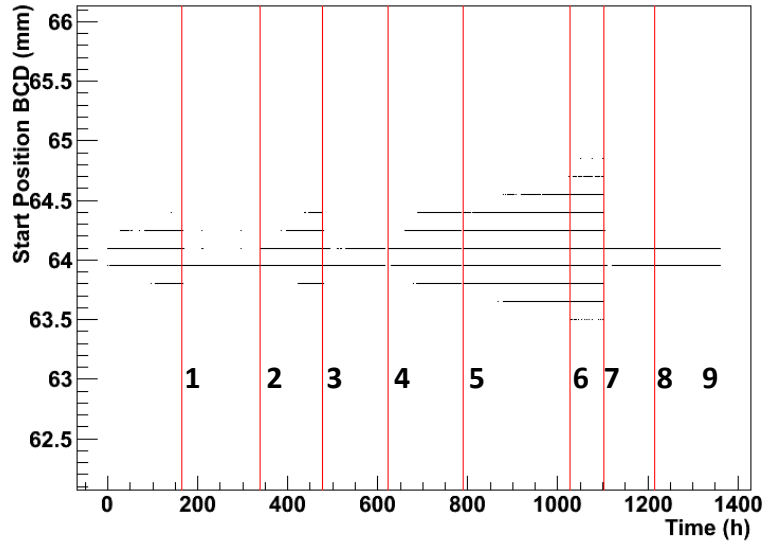
Raw Data from Start Pos BCD

Stop Time	Actuations	Description
1 - 164	490960	Inspection 1 (14/12/2010)
2 - 338	512865	Pause for Christmas, Inspection 2 (5/1/2011)
3 - 476	412043	Inspection 3 (11/01/2011)
4 - 621	414325	Inspection 4 (18/01/2011)
5 - 790	482527	Inspection 5 (26/01/2011)
6 - 1026	701662	Test Pause in running park for 1hr. (attempt reset)
7 - 1101	219747	Inspection 6 (17/02/2011)(CM29)
8 - 1214	334982	Pause, DAQ pc full
9 - 1361	436588	Final Stop (no line, end of data)

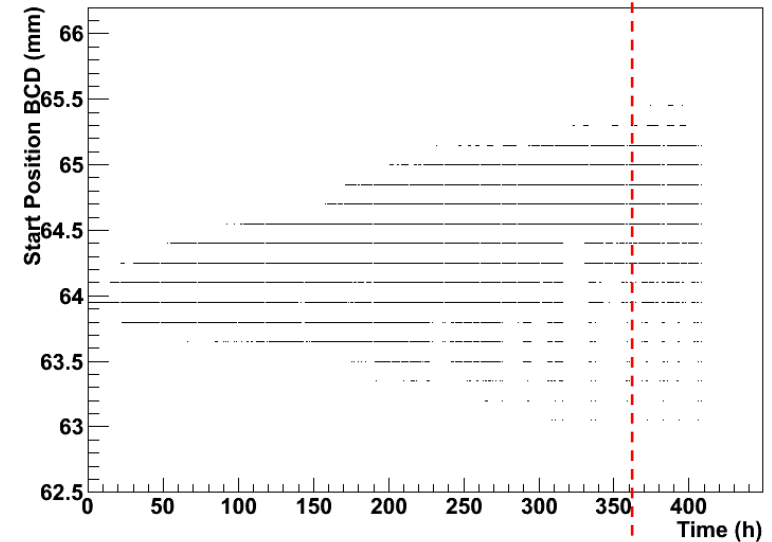
Raw Data from StartPosBCD

- Nominally identical to T2.5
- Clearances around bearings changed
- Changed inspection routine
- No weekly inspections
- 1 hour stop every day
- Several capture sticks occurred, +370 h

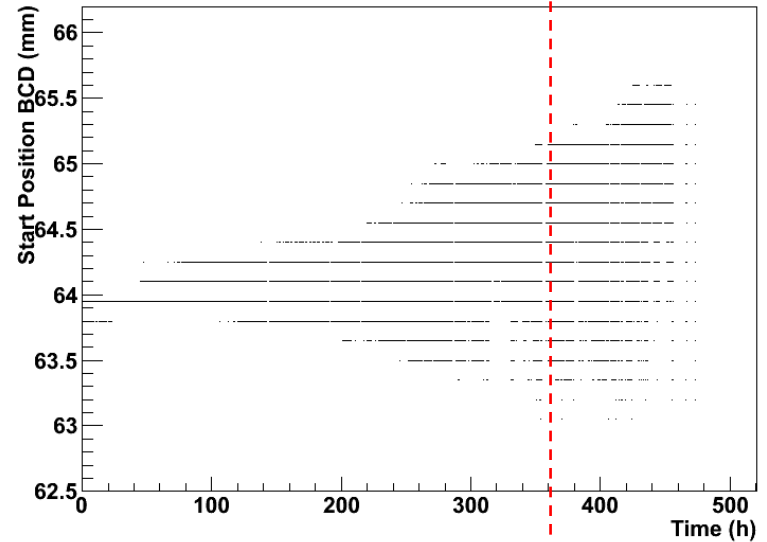
Raw Data from StartPosBCD

Clearances increased around bearings  
Daily pauses as for T2.6  
Again several capture sticks seen  
These began at 360 h
